CIVIL AERONAUTICS BOARD
ACCIDENT INVESTIGATION REPORT

PENINSULAR AIR TRANSPORT - CHICAGO, ILLINOIS, SEPTEMBER 16, 1951

PENINSULAR AIR TRANSPORT
C-46D N 74689
CHICAGO MIDWAY AIRPORT
SEPTEMBER 16, 1951

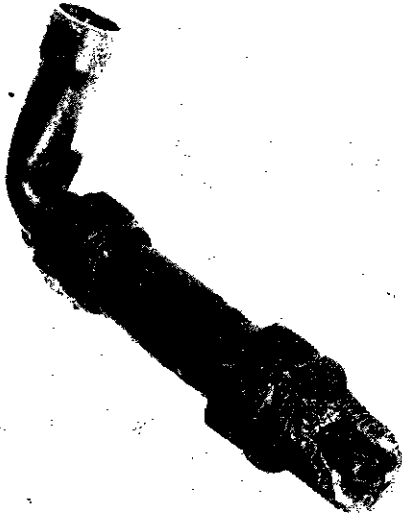
This spark plug was damaged in the same manner, but to a lesser degree, as the spark plug that came out during the flight to Chicago.

PHOTO 1
SPARK PLUG THAT
WORKED OUT EN ROUTE
TO CHICAGO
NO. 12 CYLINDER
(REAR)

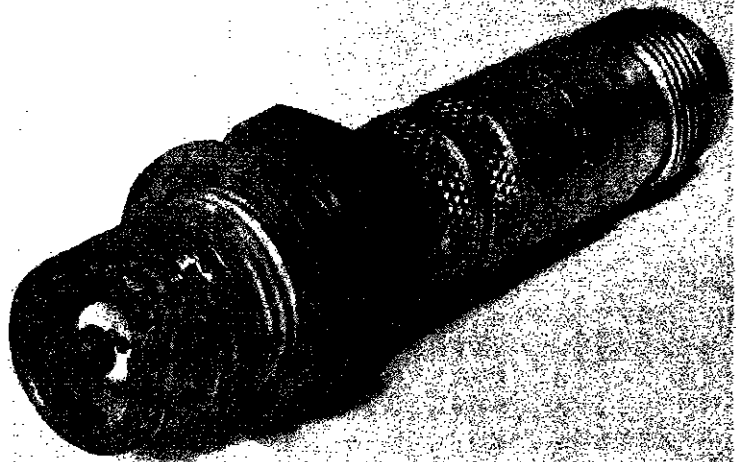
Spark plugs of the left engine were removed and examined. All appeared to be normal, except for some impact damage, with the exception of both ^{plugs} from No. 12 cylinder. The front spark plug gave indication of having run hotter than normal. The rear spark plug (the new one that had been installed on the day of the accident) was burned away for three-eighths of an inch of the circumference of its shell and the

burning extended; decreasingly, for seven-sixteenths of an inch from the inner end. Eight threads of this spark plug were partially filled with material from the bushing; it had fused to the plug. Of the four shell electrodes, one had melted and another had fused to the center electrode; all four had been subjected to extreme heat.^{3/}

It must obviously follow that the spark plug failed during these higher power settings with their higher pressure and temperature. As a considerable portion of the thread of the plug was burned away, and as the great majority of the mating surface of the spark plug's bushing had been burned away, it is apparent that there had been insufficient metallic contact between the spark plug and its bushing to allow the spark plug to cool sufficiently. Such a condition would readily result in the overheating of the spark plug to such an extent that two of its four shell electrodes melted, one fusing to the center electrode.

PHOTO 2
NEW SPARK PLUG
INSTALLED AT CHICAGO
SHOWN AFTER ACCIDENT
NO. 12 CYLINDER
(REAR)
